THE USUAL SUSPECTS

Irregular Drive Tire Conditions

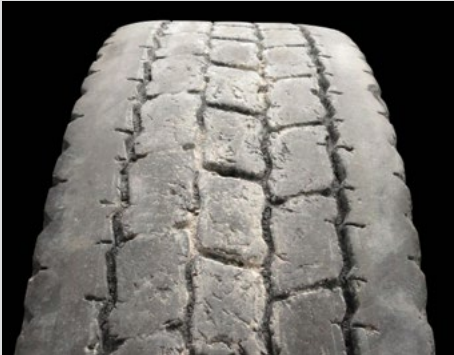
Multiple Cuts/Chunking

Appearance	Numerous small cuts to the tread surface with portions of tread removed, giving a rough appearance.
Probable Cause	Vehicle operation on rough surfaces (misapplication of tread compound).
Corrective Action	Review tire selection and operation.
Tire Disposition	Minor damage should return to service. Consult retreader for possible repair and retread.

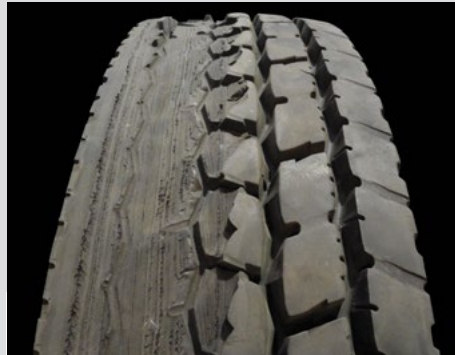
Vehicle/Spin Damage

Appearance	Cuts or lines 360 degrees around the tire.
Probable Cause	Contact with vehicle components (mud flap brackets, bumpers), or spinning the tires on ice or loose road surface.
Corrective Action	Analyze cause. Ensure tire does not contact vehicle components. Review driver practices.
Tire Disposition	Return to service if damage is not below base of tread groove. If deeper, retread or scrap.

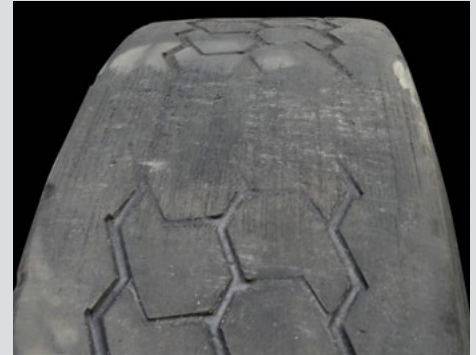
Brake Skid Damage

Appearance	Localized spot of excessive wear across tread face showing abrasion marks. Damage may extend into casing.
Probable Cause	New brakes (not worn in), unbalanced brake system, frozen brake lines, driver abuse.
Corrective Action	Check brake system.
Tire Disposition	May be repaired or retreaded if casing is undamaged; otherwise, scrap.

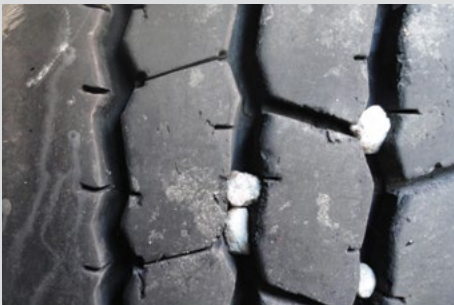
Stone Retention/Drilling

Appearance	Stones or gravel imbedded between tread blocks, sometimes reaching steel cables.
Probable Cause	Condition is common with vehicles operating on gravel surfaces. Overinflation, misapplication of the tire.
Corrective Action	Remove stones & return to service. Maintain proper inflation pressures.
Tire Disposition	Continue to run unless there are multiple spots reaching steel cables. Consult retreader or tire manufacturer.

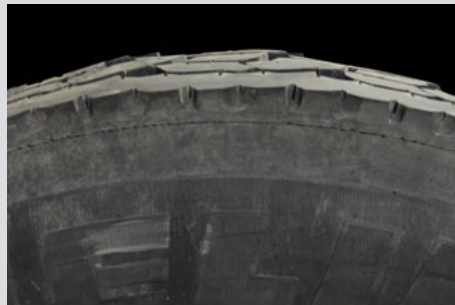
Heel/Toe Wear

Appearance	Each lug around tire worn high to low from front to back edge.
Probable Cause	Mismatched inflation pressure or tire diameters in a dual assembly. High torque conditions, mountainous terrains, and high inflation pressures aggravate this condition.
Corrective Action	Review tire maintenance practices. Consult tire manufacturer when selecting tire for operation.
Tire Disposition	Continue to run. If severe, change direction of rotation.
